Contract #: 04-0120F4Cty: SF/ALA Rte: 80 PM: 13.2/13.9File #: 99.28**WELDING INSPECTION REPORT****Resident Engineer:** Casey, William**Address:** 333 Burma Road**City:** Oakland, CA 94607**Report No:** WIR-027104**Date Inspected:** 30-Jan-2012**Project Name:** SAS Superstructure**OSM Arrival Time:** 700**Prime Contractor:** American Bridge/Fluor Enterprises, a JV**OSM Departure Time:** 1530**Contractor:** L & M Industrial Fabricators**Location:** Tangent, Oregon**CWI Name:** Tom Dreyer**CWI Present:** Yes No**Inspected CWI report:** Yes No N/A**Rod Oven in Use:** Yes No N/A**Electrode to specification:** Yes No N/A**Weld Procedures Followed:** Yes No N/A**Qualified Welders:** Yes No N/A**Verified Joint Fit-up:** Yes No N/A**Approved Drawings:** Yes No N/A**Approved WPS:** Yes No N/A**Delayed / Cancelled:** Yes No N/A**Bridge No:** 34-0006**Component:** Tower Head Parapet**Summary of Items Observed:**

CCO: 196 - Description: Construct parapet walls at the Tower Head

North Tower Chimney Parapet:

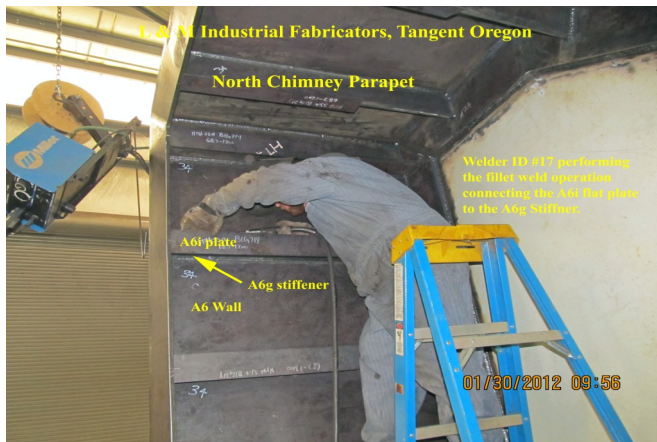
This QA Inspector randomly observed L & M welder Jake Schuld (Welder ID #17) performing the fillet weld pass operation per the Flux Cored Arc Welding (FCAW-G) gas shielding process in the (2F) horizontal position connecting a flat plate-(A6i) to stiffener plates (A6e, A6f and A6j) that were previously welded to the internal side of parapet wall plate-(A6b) of the North Tower Chimney Head. This QA Inspector observed QC Inspector Tom Dreyer verify prior to the start of the fillet weld operation that the minimum preheat temperature as per the approved WPS was established and afterwards verified that the welding parameters (Amps, Volts and Travel Speed) were in accordance with WPS-D1.5-FC-006-2F using Hobart Excel Arc E71T-1 (.052") diameter electrode.
